Manhole Inspection Summary

Manhole # S15EE2010MH

Insp Date: **9/29/06 1:20 PM**

Location Address: **1915 KELLY AVE**

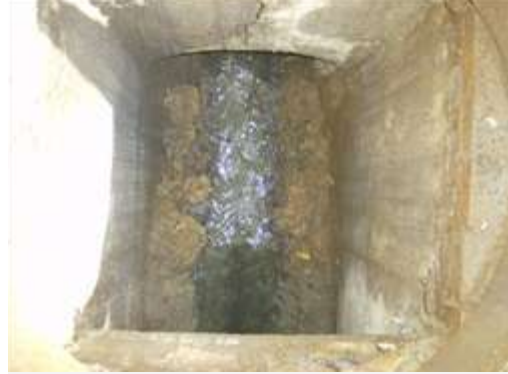
Top View

Barrel cracks and infiltration. Channel debris.

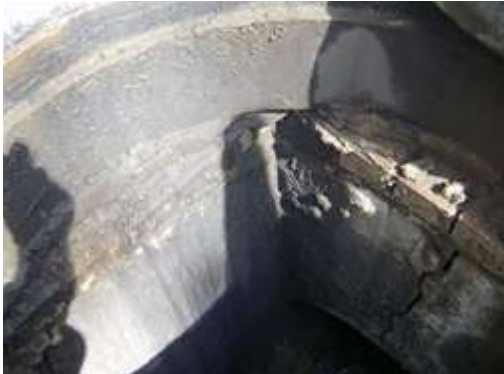
Defect

Frame leaks. Frame offset. Adjustment deterioration and infiltration. Corbel cracks and infiltration.

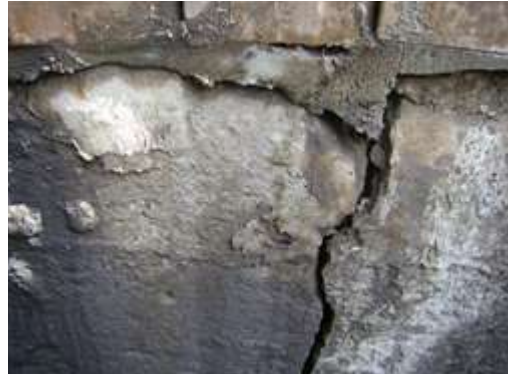
Defect

Corbel cracks.

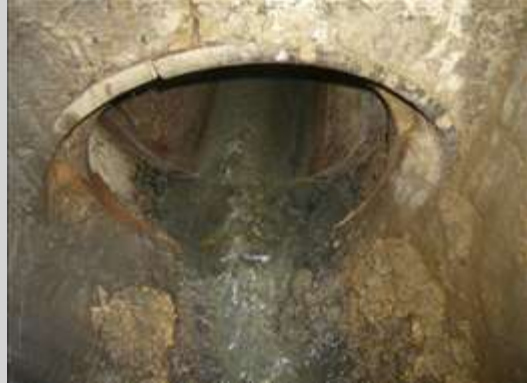
18 in. Circular Gravity Sewer Pipe Out @ 12 O'Clock

Deposits: ☐ None ☒ **Mud** ☐ Sludge ☒ **Debris** ☐ Grease

Silt Depth: **0.5** (in.) Deposits Extent: **Light**

Infiltration: **Evidence** Pipe Seal Cond: **Cracked**

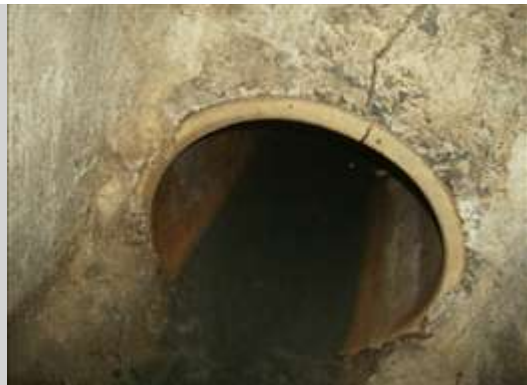
18 in. Circular Gravity Sewer Pipe In @ 6 O'Clock

Deposits: ☐ None ☒ **Mud** ☐ Sludge ☒ **Debris** ☐ Grease

Silt Depth: **0.5** (in.) Deposits Extent: **Light**

Infiltration: **None** Pipe Seal Cond: **Cracked**
